# 2020 FUEL OIL QUALITY AND SAFETY SURVEY

On 24 February 2020 BIMCO, The International Chamber of Shipping (ICS), INTERCARGO and INTERTANKO launched The Fuel Oil Quality and Safety Survey with the aim to get a greater understanding of the quality of the new fuel oils and possible safety implications of the IMO 2020 sulphur regulation.

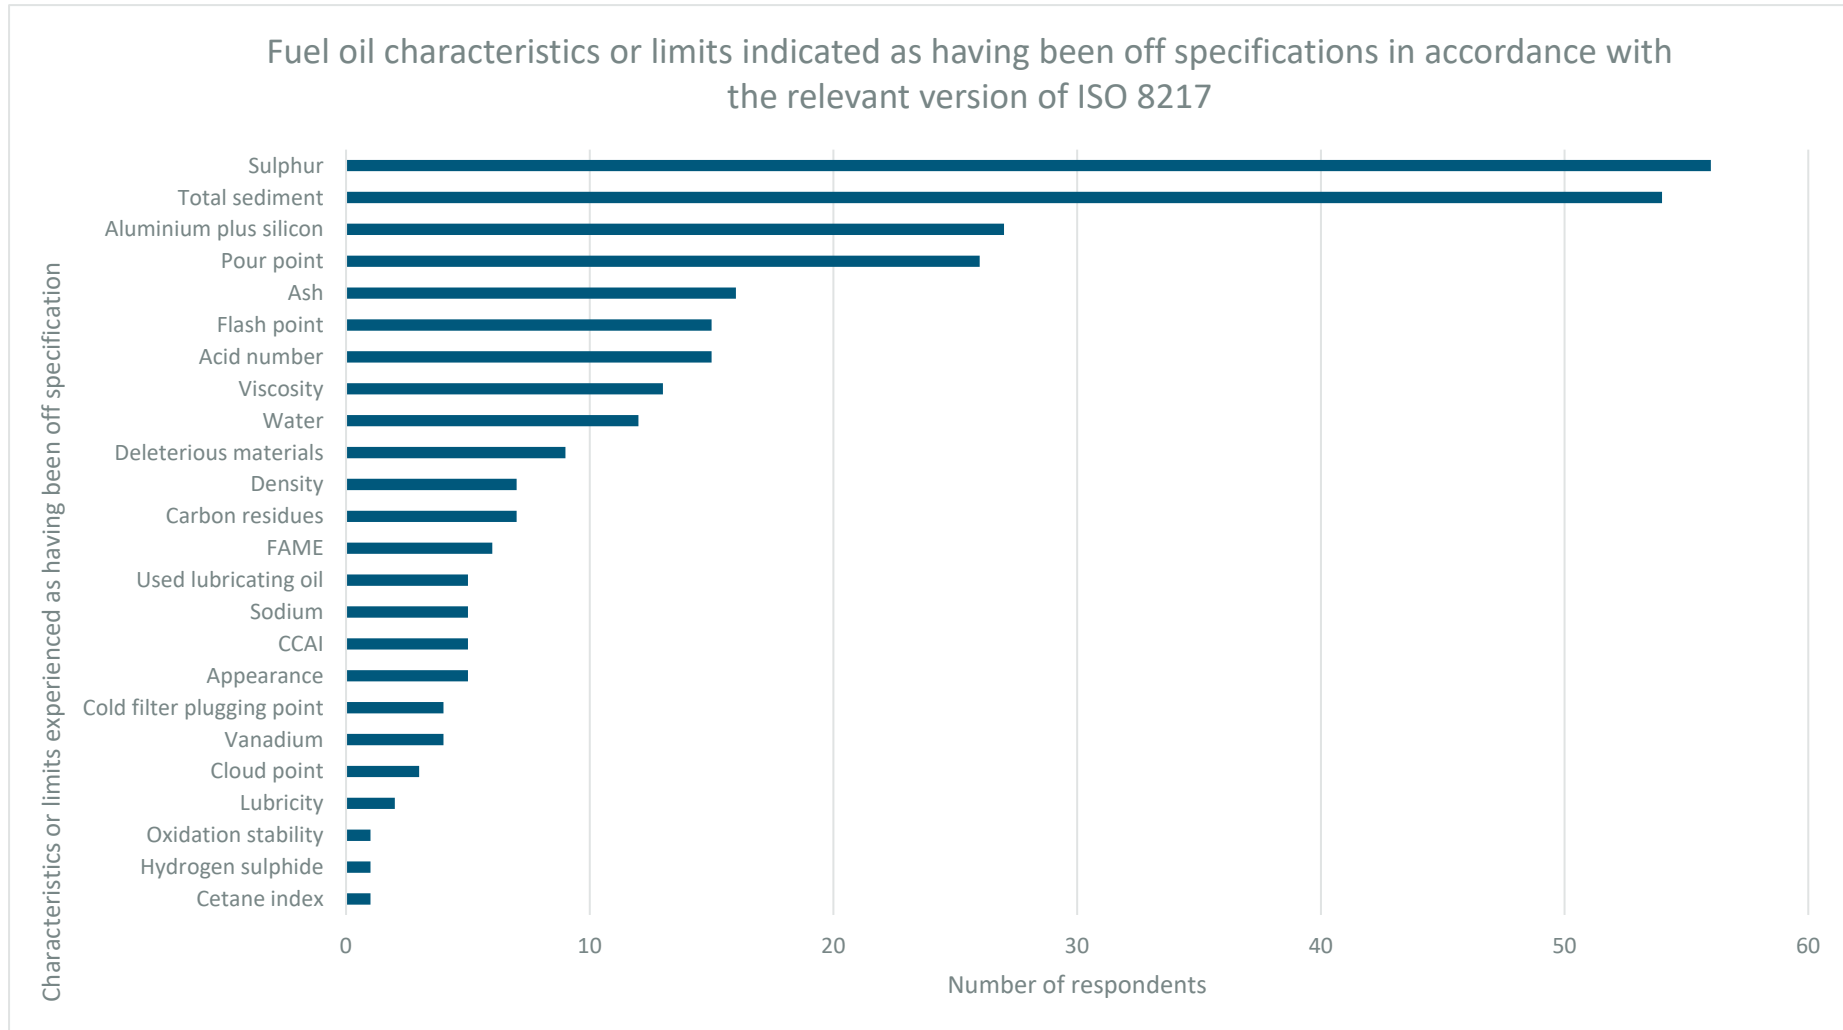
**Annex C – (Q2-2) Fuel oil characteristics or limits indicated as having been off specifications in accordance with the relevant version of ISO 8217**

The eight most selected characteristics or limits in accordance with ISO 8217 as experienced being off specifications (off-spec):
